Country Fire Authority

Report of the Investigation Team

Wonga Park Pumper/Tanker

Kinglake Fire Complex

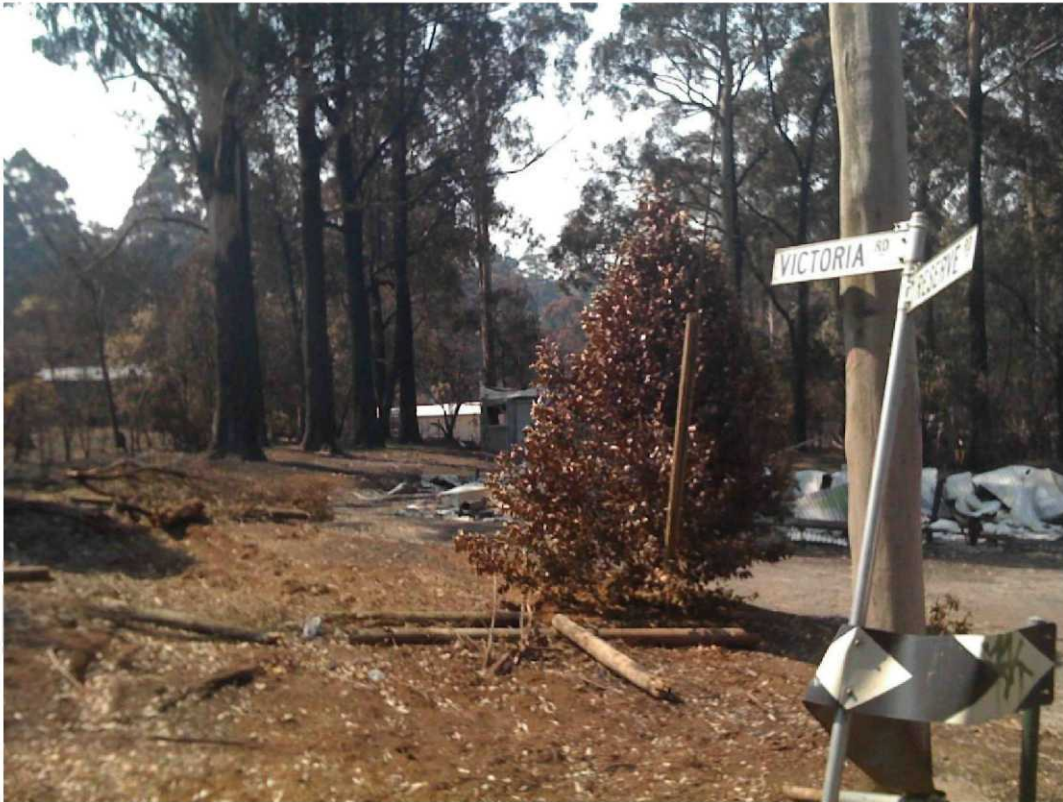
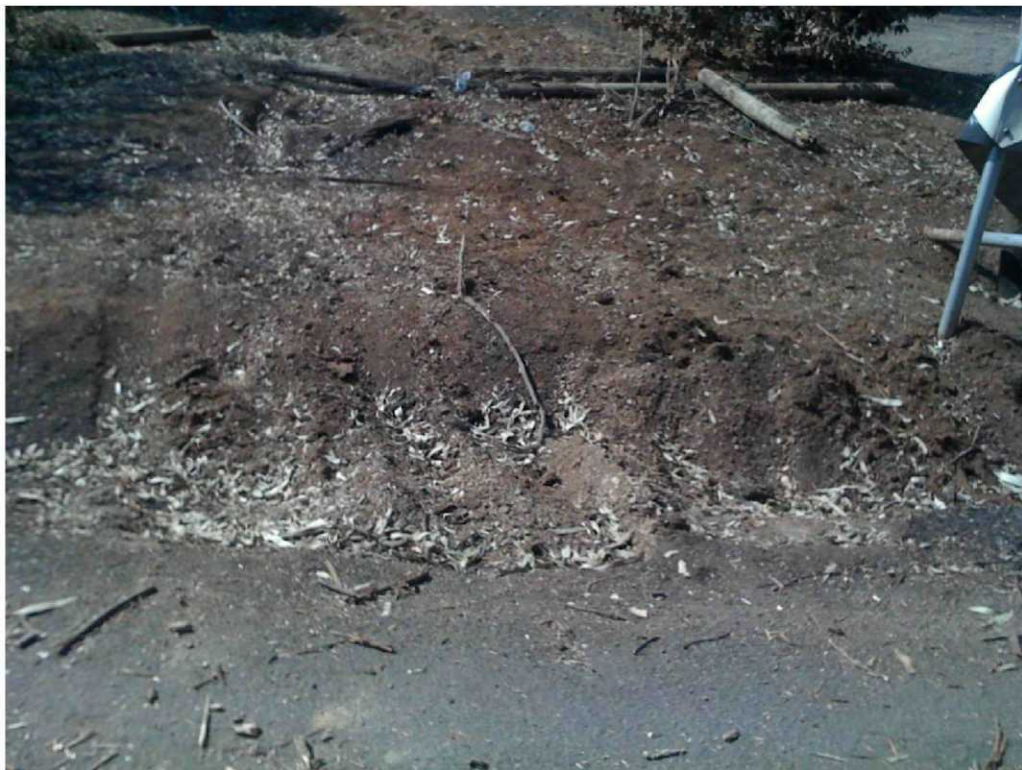
When Wonga Park Pumper/Tanker pulled up along side Nth Warrandyte Tanker 1 they noticed it was facing in the opposite direction and had been driven off to the side of the road into a culvert. Fire was surrounding the vehicle. Trees and bushes along the side of the road were burning freely. Houses on all corners of the nearby intersection were totally involved.

Above: The intersection of Victoria Road and Reserve Road showing where Nth Warrandyte Tanker 1 ended after swerving to miss a burning tree falling in its path.
Below: The culvert itself.
