Country Fire Authority

Report of the Investigation Team

Wonga Park Pumper/Tanker

Kinglake Fire Complex

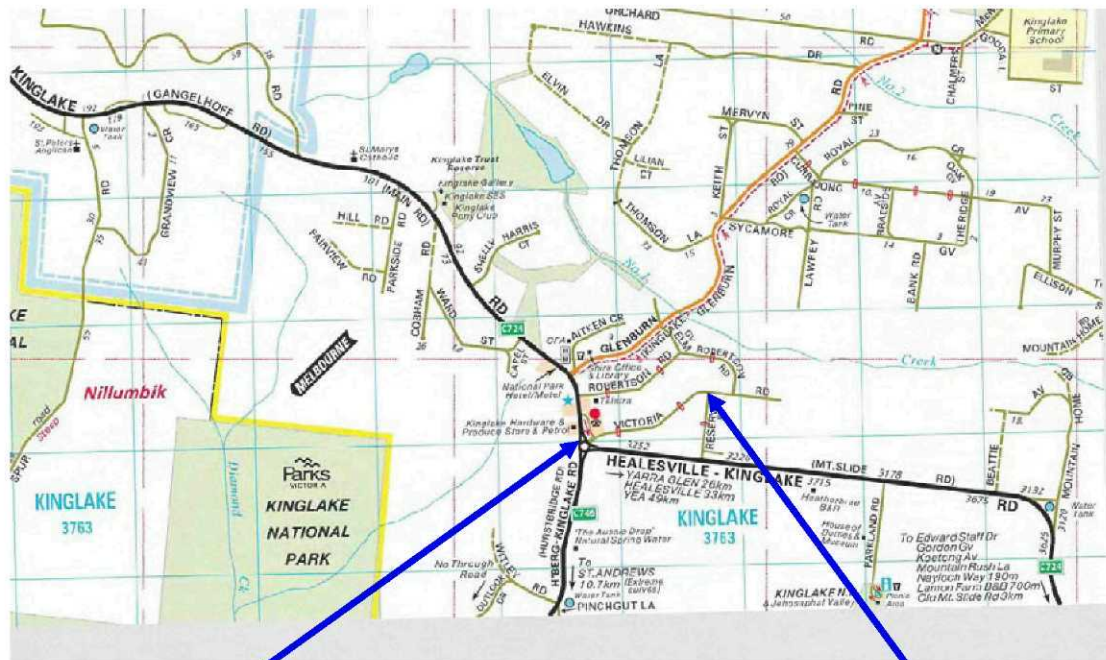
The roundabout where Wonga Park Members had a chance meeting with civilians who advised they had seen red/blue flashing lights in Victoria Road.

The approx. location where Wonga Park finally located the stricken Nth Warrandyte Tanker 1 and its crew.
